Leading versus Lagging Indicators of Tailings Dam Integrity

Jeremy Boswell and John Sobkowicz
Thurber Engineering Ltd., Calgary, Alberta, Canada

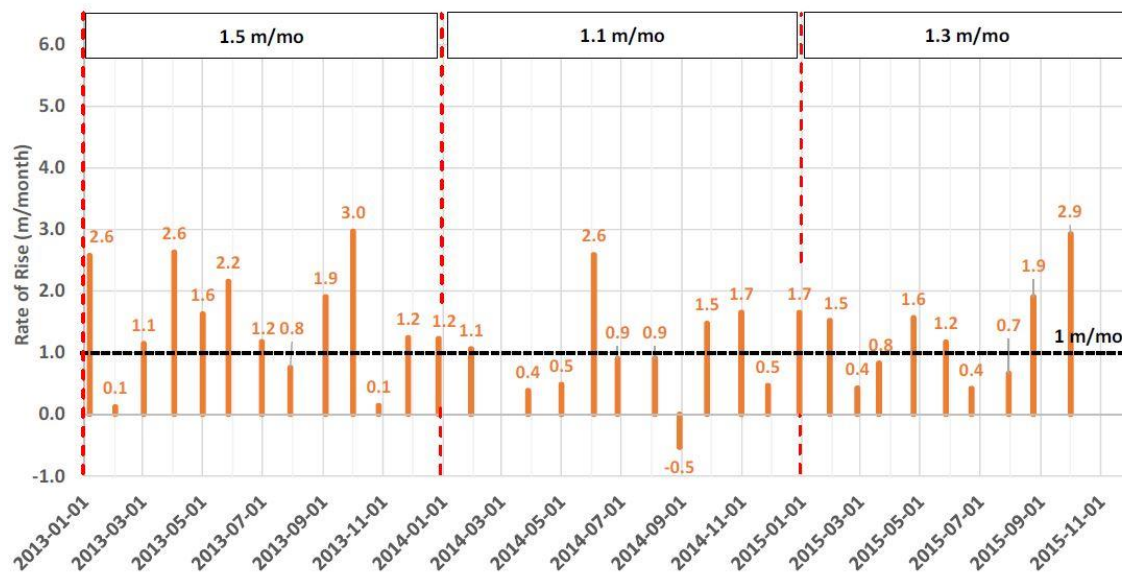
Figure 1. Rate of dam crest rise at Fundão left abutment setback (from page 49, Morgenstern et al, 2016)

Morgenstern et al (2016) describe very high incremental monthly and annualized rates of rise that immediately preceded the Fundão tailings failure, in some cases up to an annualized rate of rise of 35 metres per year (Figure 1). It is no coincidence that upon breaching, the entire contents of the Fundão tailings facility were lost, a most unusual tailings failure characteristic.

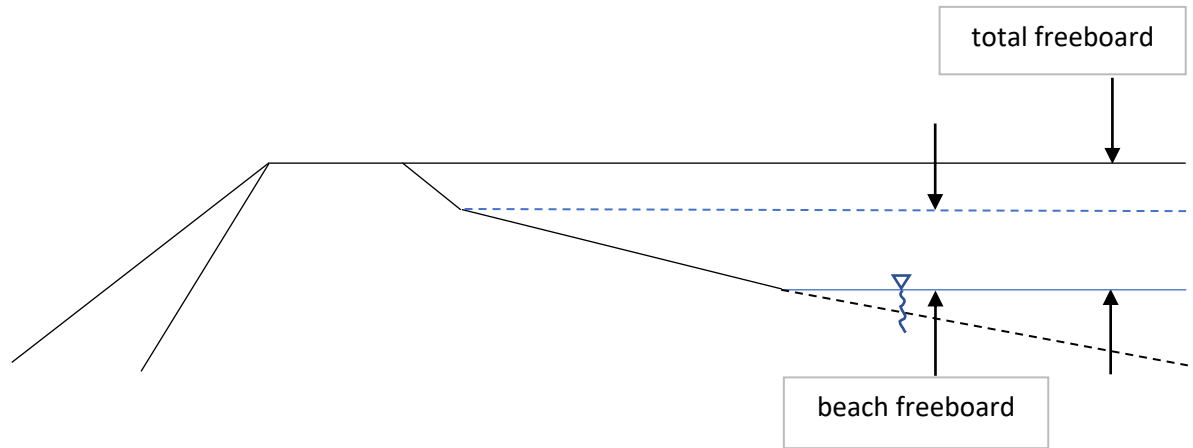
Figure 2. An illustration of the meaning of beach freeboard (vertical scale exaggerated)

As illustrated in Figure 2, total freeboard provides the (as-measured) overall defense against overtopping, and may be rapidly improved by elevating the crest of the dam. Beach freeboard is much harder won but provides a number of additional benefits:

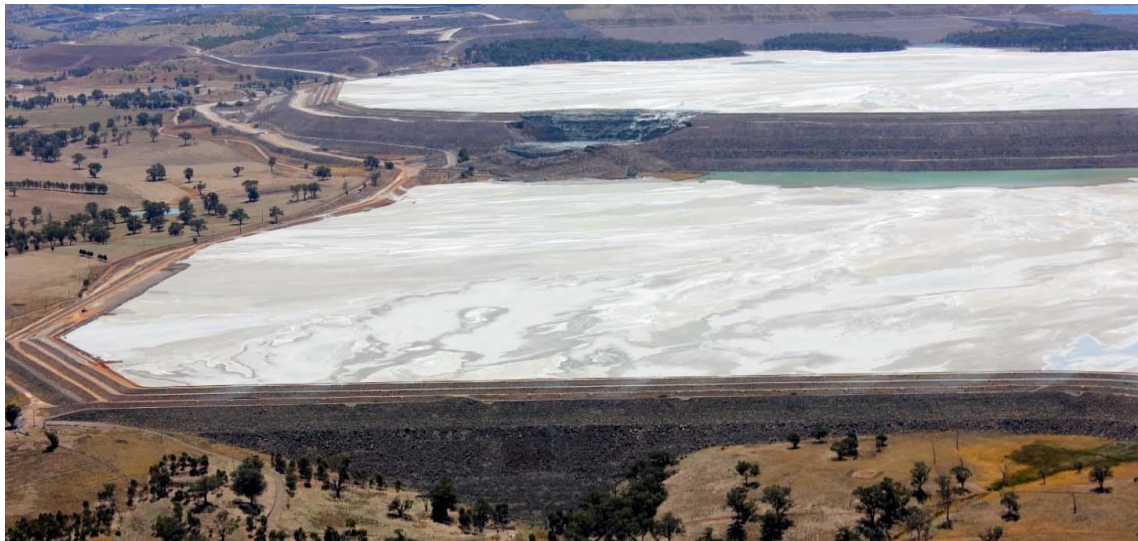
Figure 3. Slope failure in upper compartment at Cadia, Australia (Cadia press release, 2018)

The clearest illustration of the value of beach freeboard in defense against catastrophic failure, may be found in a photograph of the Cadia tailings failure (Cadia, 2018) in Australia, in May of this year, shown in Figure 3 below.

Without the added protection of the significant beach freeboard shown in the photograph, the local slope failure shown in the upper compartment would not have been contained, but instead

would likely have become a catastrophic tailings flow failure, cascading into the lower compartment and adding to the flow volume with multiplied severity of downstream consequences.
