# International tailings failures and best available technology

# Jeremy Boswell and John Sobkowicz *Thurber Engineering, Canada*

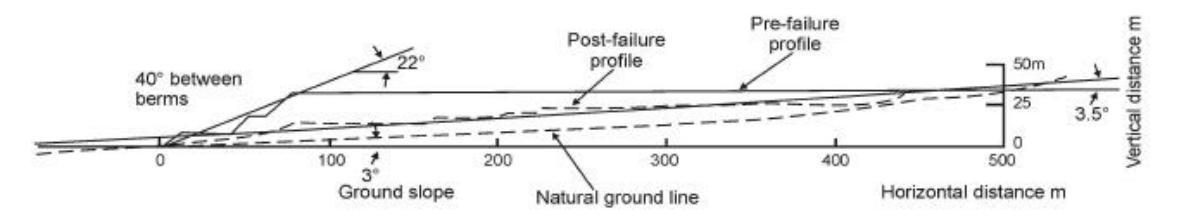
Figure 1. Pre-and post- failure profiles of EI Cobre old dam (from Blight & Fourie [2003])

The sketch below from Blight & Fourie (2003) shows a pre-failure embankment slope angle of 22 degrees flattened to no more than 3.5 degrees post failure on the El Cobre old dam. The natural ground slope was only 3 degrees.

As a result of the El Cobre failure, in 1970 the Chilean authorities intervened by issuing a decree (Decree No. 86) which imposed far reaching effects on Chilean tailings practice. Among the many changes were abolition of the upstream construction method for tailings dams, and requirements to apply the laws of soil mechanics to tailings dam construction (Cabrera, 2011).

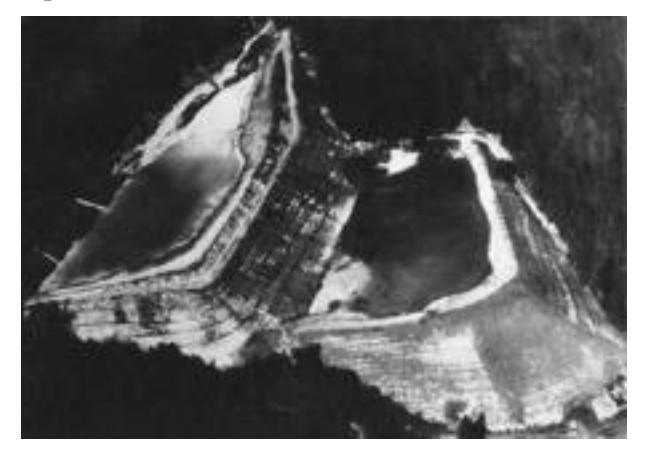
Figure 2. Aerial view of the dams at Stava before failure (ref Foundation Stava 1985' http://www.stava1985.it/)

According to the subsequent inquiries, the collapse was caused by the chronic instability of the dams, especially in the upper one, which were below the minimum factor of safety required to avoid collapses. The upper basin measured 34 metres in height and was built at an angle of 40 degrees as an upstream tailings dam, on natural ground whose slope was approximately 25 percent.

The Commission further found "the decision to enlarge the bank according to the upstream method, which was the quickest and most inexpensive, but also the most dangerous".

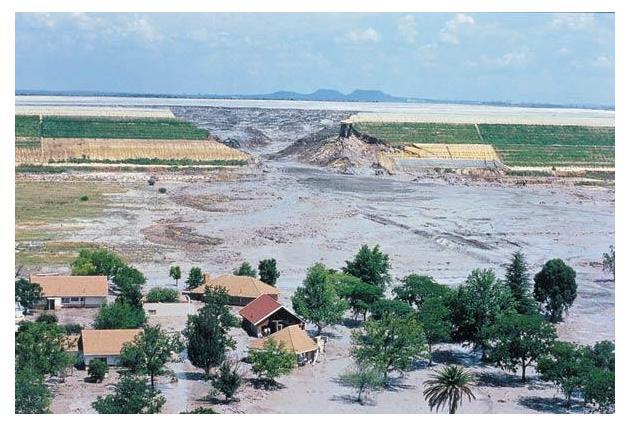
Figure 3. Merriespruit tailings failure (www.infomine.com)

On the night of 22 February 1994 a 31 m high tailings dam upslope of Merriespruit, a suburb of the town Virginia, failed with disastrous consequences (Wagener et al, 1997). The dam failed a few hours after 30 to 50 mm of rain fell in approximately 30 minutes during a late afternoon thunderstorm. The failure resulted in some 600 000  $m^3$  of liquid tailings flowing through the town, taking the lives of 17 people and causing wide-spread devastation of property and environmental damage.

Static liquefaction during undrained loading of the Merriespruit tailings contributed substantially to the catastrophic flow slide that occurred in February 1994 (Fourie et al, 2001). Why previous incidents of slope failure or overtopping of gold tailings dams in South Africa did not also result in catastrophic flow-slide failures was that much of the Merriespruit tailings were in an intrinsically unstable state in situ prior to the failure. The underlying cause was the same

reason that the failure was triggered: poor management of the tailings impoundment and particularly poor control of the tailings pond.

The Merriespruit disaster provided an impetus for both the South African mining industry and the state to take a more responsible and serious approach to disposal of tailings (Wagener et al, 1997). A fundamental re-assessment of the philosophies for design, management and operation of tailings dams was initiated in South Africa. The mining industry began to carry out independent self-audits, viewing tailings dams and associated problems far more seriously than in the past. In 1995, work started to draft an obligatory Code of Practice for the design, operation management, rehabilitation and closure of tailings dams. It was published in 1998 as SABS 0286: Code of practice for mine residue.

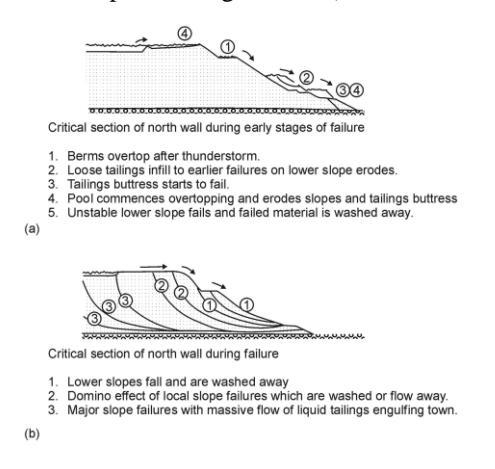
Figure 4. Merriespruit progression of failure (Blight & Fourie, 2000)

In comparison with other catastrophic tailings failures, the tailings volume released at Merriespruit was relatively small (600 000  $m^3$ ). However, there were many grievous human errors that contributed further to the severity and consequences of the failure:

- The design decision to locate the recycle water dam upstream of the tailings facility, thus disallowing the gravity flow of supernatant and precipitation from the impoundment to the recycle water dam.
- The planning decision to allow the construction of a mine village immediately downstream of the tailings facility in the early planning stages of the mine.
- The operational decision to combine the upper and lower compartments of the facility years before the failure, by accelerating the rate of rise of the lower compartment.

This contributed to the poor state of consolidation of the tailings in the vicinity of the failure.

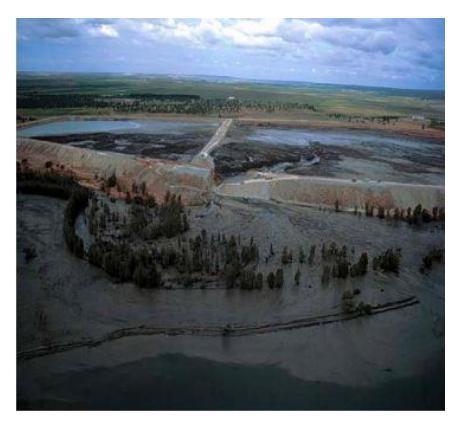
Figure 5. Los Frailes tailings failure (Ref http://en.wikipedia.org/wiki/Dam\_failure)

The 25-m-high dam rested on roughly 4 m of river-terrace alluvium underlain by 70 m of blue marl. At a depth of approximately 10 m into the marl, overstressing of the marl beyond its peak strength by construction-induced pore pressures allowed the dam, alluvium, and shallow marl to slide along a near-horizontal bedding plane to the east (Eptisa, 1998). This resulted in liquefaction of the pyrite tailings, which in turn increased the loading on the dam as the foundation resistance was decreasing. These processes accounted for the 60 m horizontal displacement of the dam, which is considered unusually high. Other factors like earthquakes, blasting, acidic drainage, and seepage of groundwater were ruled out as contributors to the dam failure.
